Analysis of Riverbank Stability Due to Bamboo Vegetation in Walanae River, South Sulawesi, Indonesia

ANALYSIS OF RIVERBANK STABILITY DUE TO BAMBOO VEGETATION IN WALANAE RIVER, SOUTH SULAWESI, INDONESIA

Nurlita Pertiwi, Bakhrani A. Rauf, Mithen

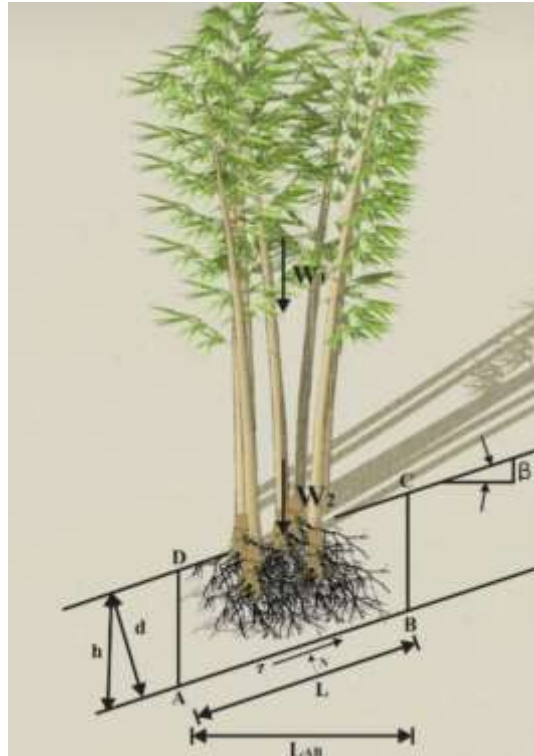
Figure. 1. Description of Plant Weight on Cliff Stability,

In this study, the destabilization of riverbanks by bamboo growth was visually assessed. The increase in block weight which was observed due to the increased soil mass and plant weight contributed to the addition of shear forces therefore, the risk of collapse was even greater. In the slope stabilization study, the mass collapse was assessed based on the value of safety factors, which when greater than 1.25 indicates cliff collapse [14]. Furthermore, bamboo growth was characterized by an increase in plant weight. Therefore, the study of the biomass of bamboo plants may be estimated by its diameter. The weight of bamboo as input to the tree surcharge is described in Figure 1.

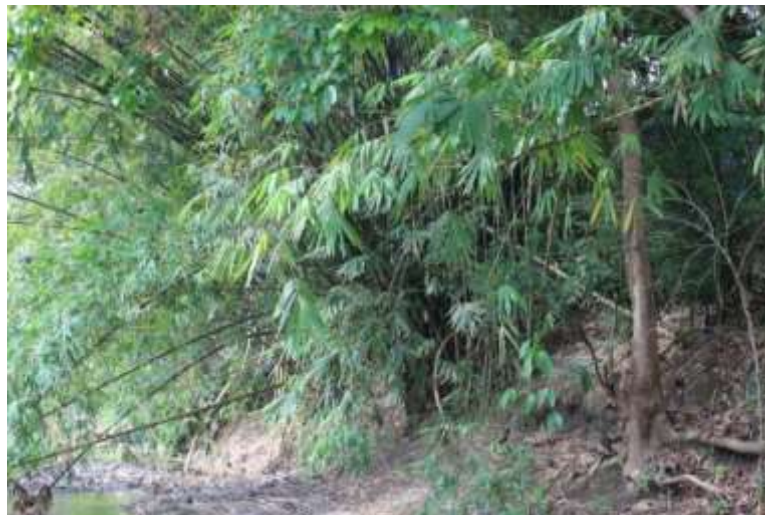
Bamboo plants were discovered along the Walanae River and the results of this study showed that most of the bamboo plants were the result of 3-5years community culture (Figure 4). It is a commodity with a high selling value, due to its very intensive use, both as building materials for houses on stilts for residents in Soppeng and Wajo districts, traditional events, or for other purposes. People tend to choose riverbanks for planting bamboo, because their crops are easily transported to other locations via rivers and farmers also use the flow of water to transport bamboo to producers. In addition, this plant has resistance to standing water due to flooding therefore, it is considered suitable for planting in riparian areas.

Figure 4. Bamboo groves on the banks of the Walanae river

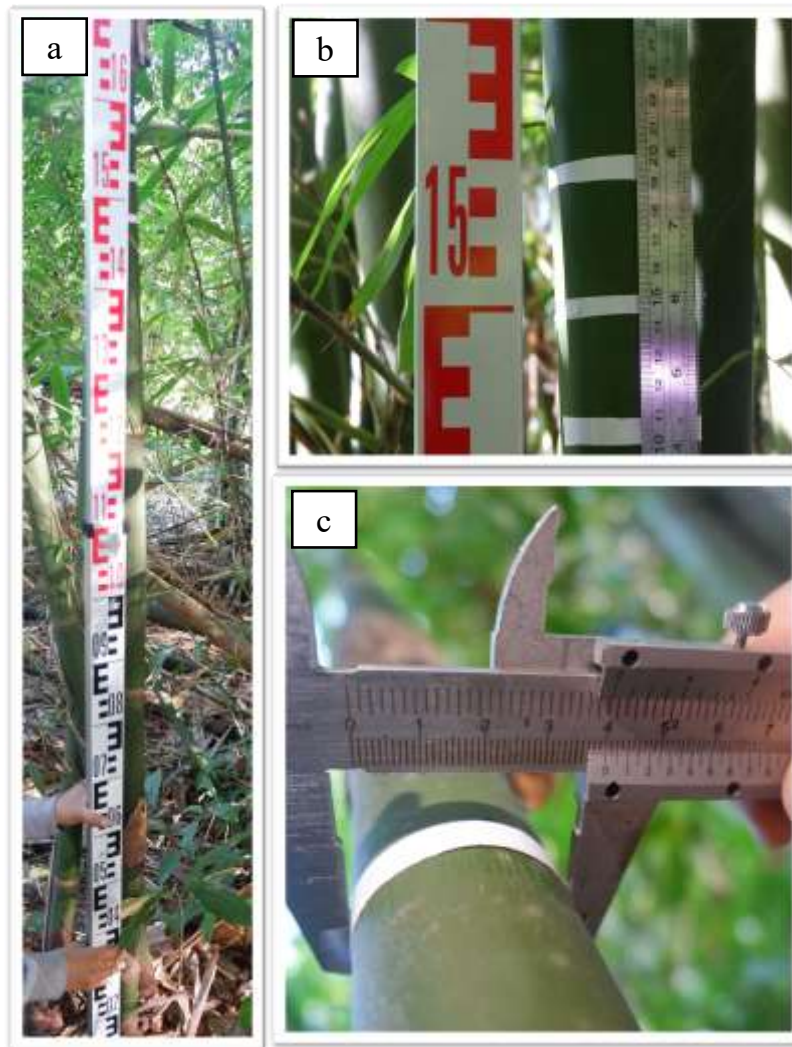
Figure 3. The Measurement of Pole Diameter.

Measurement of bamboo characteristics was carried out in January 2020 - March 2020. The middle area of the Walanae River was chosen as the sampling location with a river length of 42.4 km. There were 46 clumps of *Parring Bamboo* (*Gigantochloa Atter*) that became the research sample. As one of the endemic species in Indonesia, bamboo grows in the riverbank of the Walanae River. Figure 3 describes the measurement of pole diameter. It started with the determination of observation points (Figure 3a). Furthermore, Figure 3b shows the point in the stem height of $150 \text{ cm} \pm 5 \text{ cm}$ (Yuen et al, T. 2017). Figure 3c shows the measurement of pole diameter using a caliper.

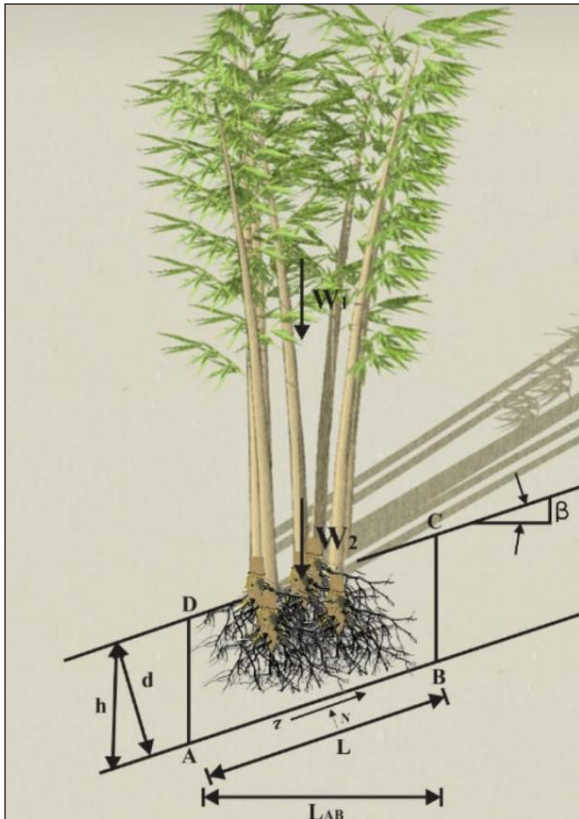
Figure 1. Description of plant weight on cliff stability

(W2). The combination of plant and soil mass is described in Figure 1. ~~Based-On the basis of on~~ this combination, this research ~~is-was~~ divided into two objectives. The first objective ~~is-was~~ to find the weight of bamboo estimated by the diameter of poles. ~~While~~ The secondary aim of the study is the risk of collapse. In the slope stabilization study, the mass failure was assessed based on the value of safety factors, which indicates cliff collapse when greater than 1.25 (WSDOT, 2005).
